Financial Optimization of Condition Assessment Spending for Pipeline Replacement Programs

Gerard Hientzsch– Echologics

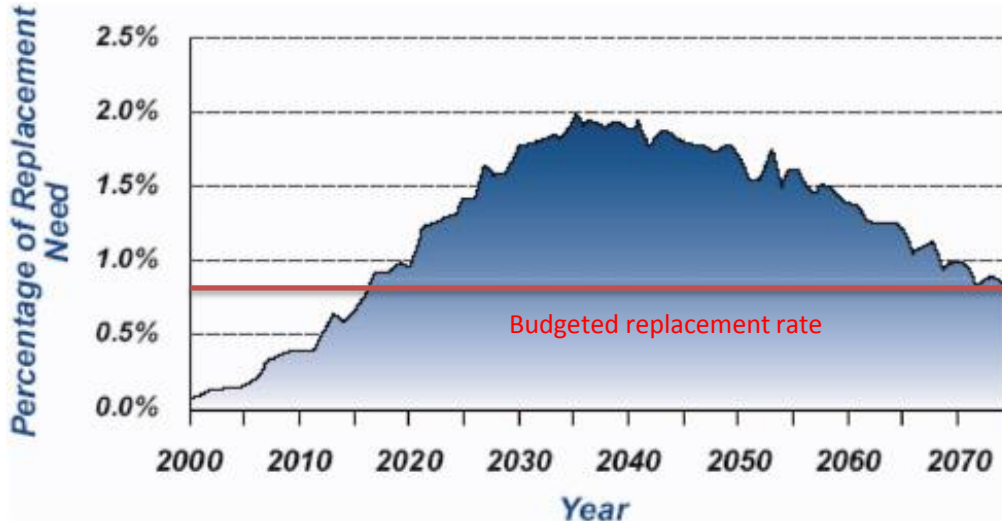
Projected annual replacement needs for transmission lines and distribution mains, 2000–2075. SOURCE: EPA (2002c)

- Many water mains were installed between 1950 and 1980
- These will reach their design life together in a large wave
- Capital funds insufficient to meet the need

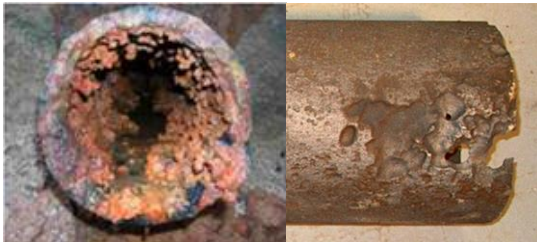
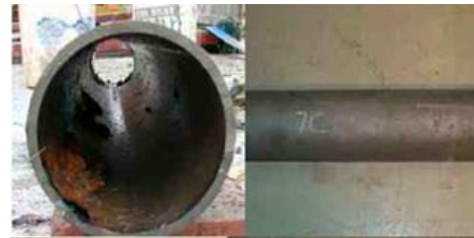
Pipeline 1	Pipeline 2
Installed 1860	Installed 1860
Brown sandy soil	Brown clay soil
Moderate soil corrosivity	Moderate soil corrosivity

Decision = Replace

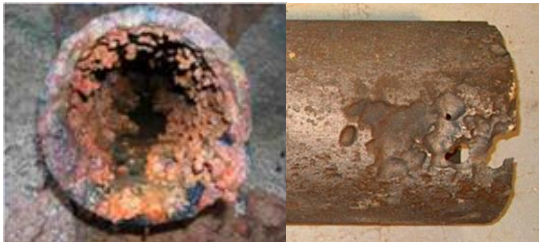
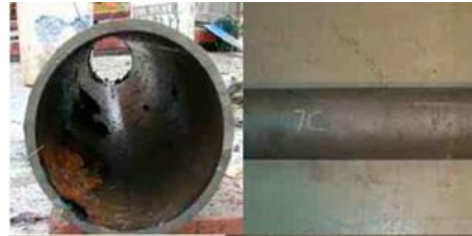
Pipeline 1	Pipeline 2
Installed 1860	Installed 1860
Brown sandy soil	Brown clay soil
Moderate soil corrosivity	Moderate soil corrosivity
Inspection Results: 31% degraded	Inspection Results: 1% degraded
Inspection Condition Prediction: Poor	Inspection Condition Prediction: Good

Decision = Replace

Decision = Keep

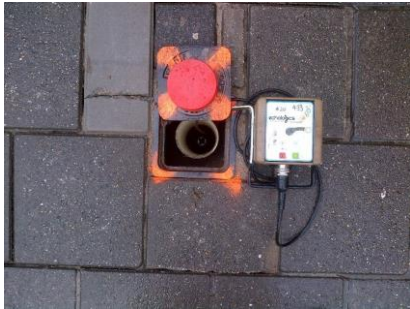
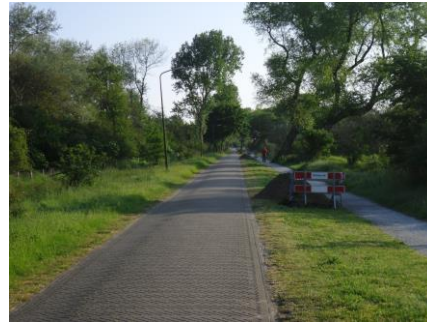
Case Study 2: Dutch Water Company – Summary

- 11,500 miles of mains serve 1.2 million customers
- 186 miles / year of replacement
- Group mains into cohorts with same neighbourhood, material, and year of construction
- Take several condition measurements in each cohort
- Old program: cut out samples of older pipes
- New program: non-invasive, non-destructive testing
- Currently testing 7% of mains
